APPENDIX U

Probable Construction Cost Estimate, Miner Flat Dam, February 1995

MINER FLAT DAM

WHITE MOUNTAIN APACHE TRIBE

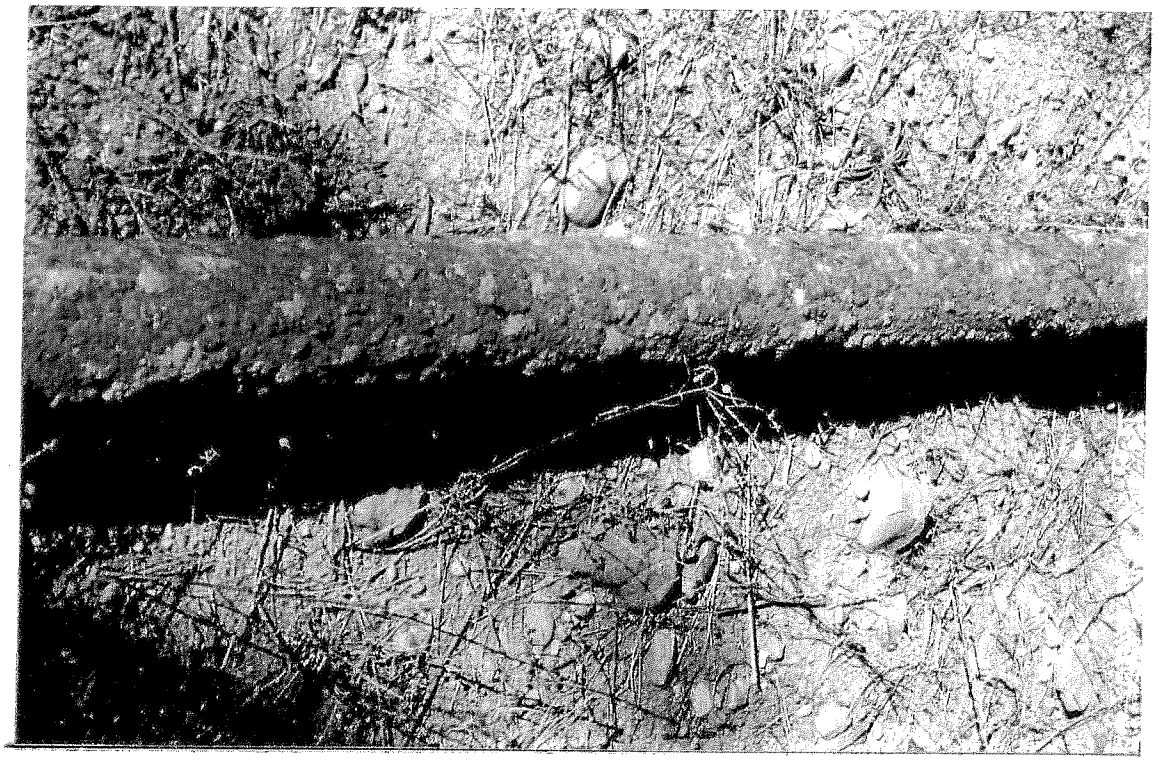
The pits corroded into the pump column, and presumably into the well casing, are the direct result of deposits of iron oxide from cascading water providing an environment where a biofilm can develop to protect anaerobic microbiological growth that in turn corrodes the pump column and casing. In Well No. 1, the iron oxides are deposited on the well screen rather than on well casing, raising the issue of plugging of the well

Photograph 3.1: Iron oxide incrustation on Well No. 1 pump column.

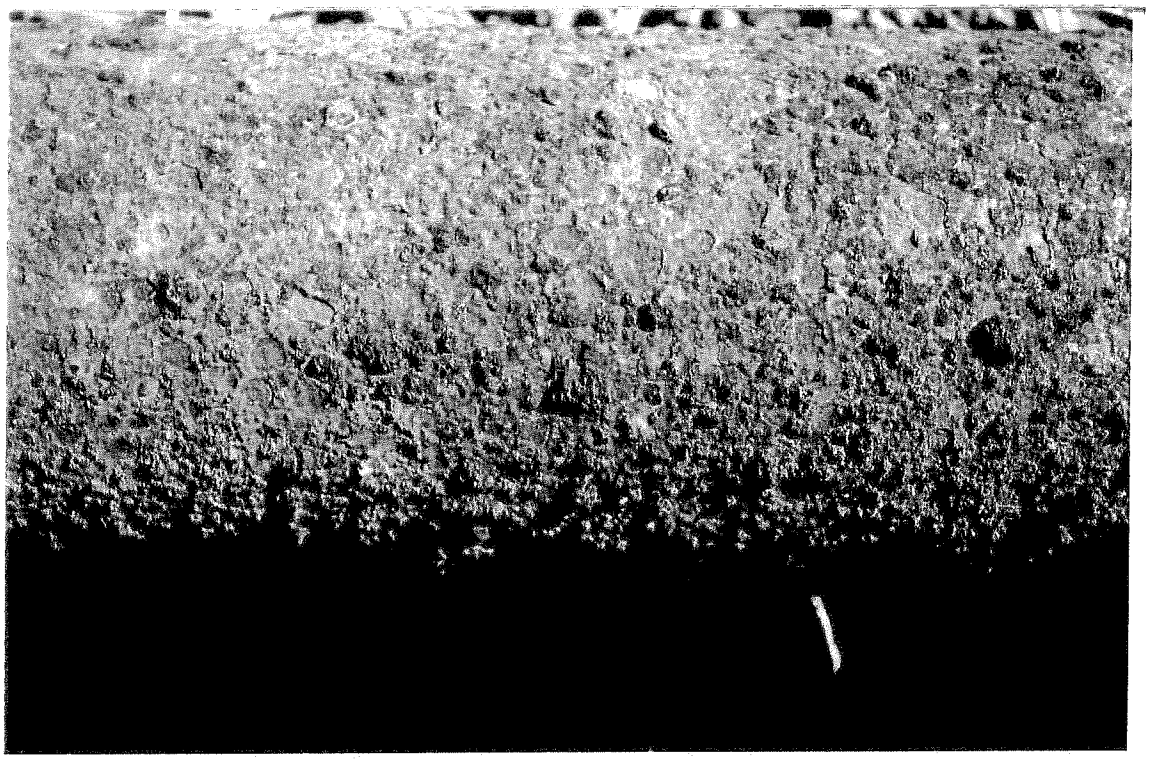
Photograph 3.2: View of thickness of iron oxides on Well No. 1 pump column.

Photograph 3.3: Tubercles and corrosion pits on pump column, Well No. 1.

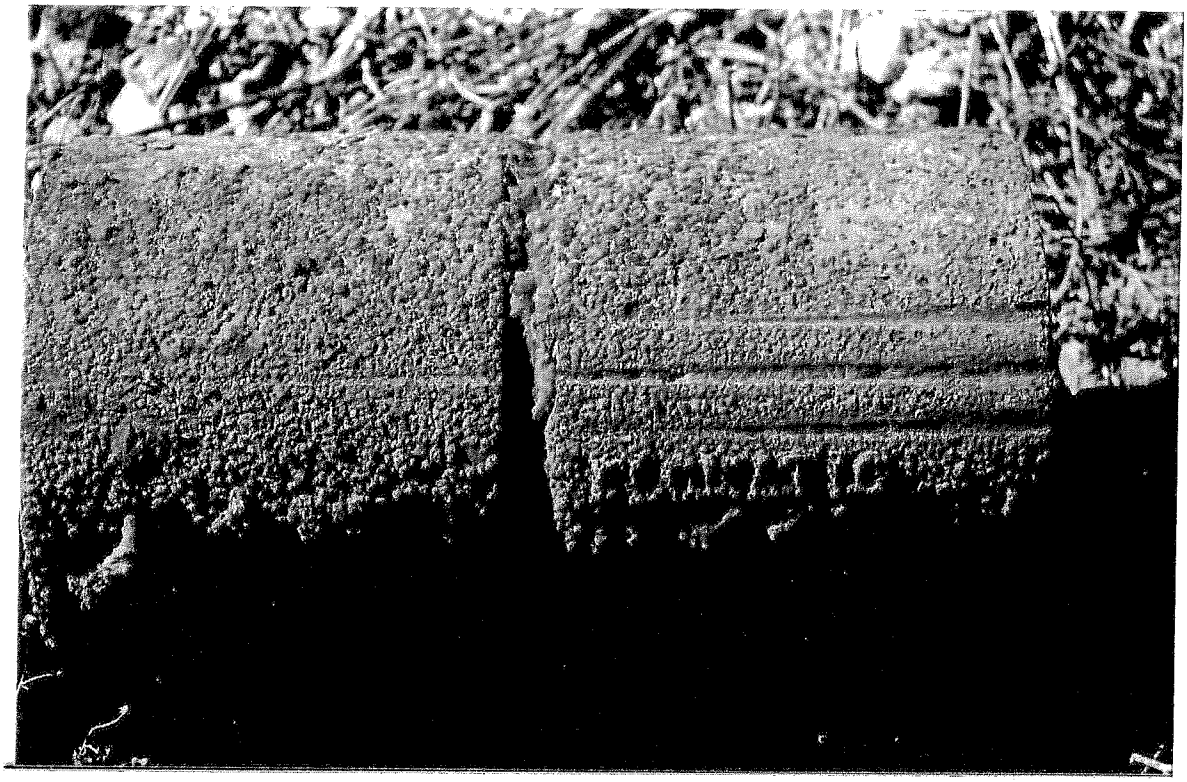
Photograph 3.5: Well screen rods imprint on Well No. 1 pump column check valve.

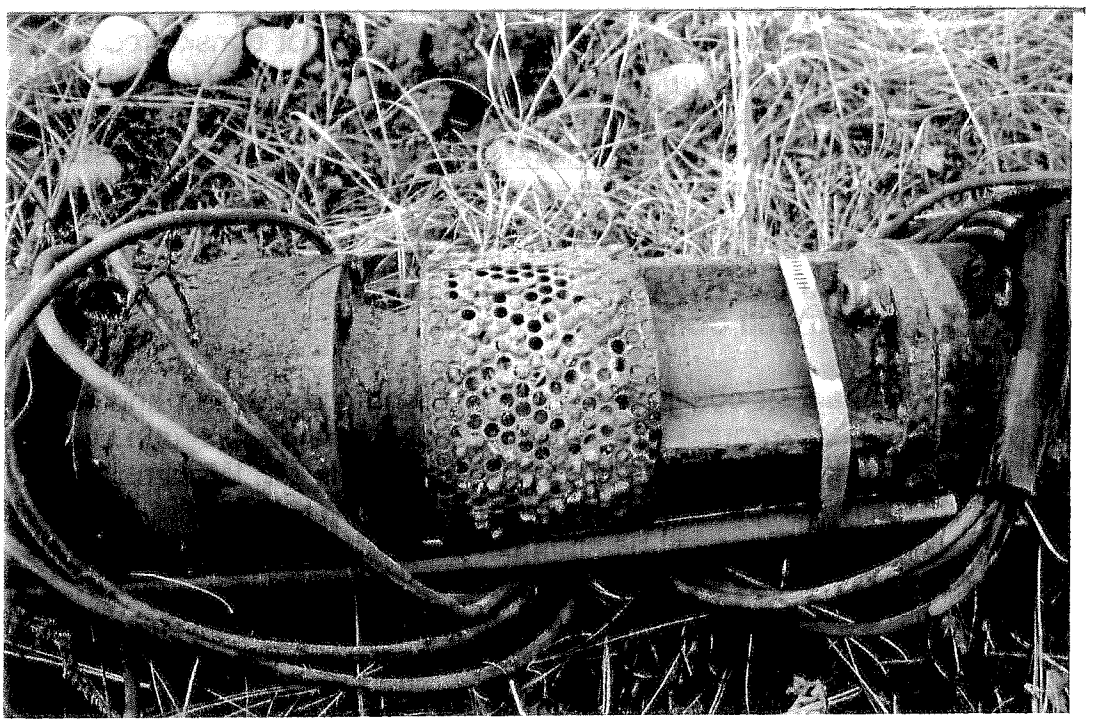
A December 2001 inspection of the pump pulled from the well earlier in 2001 provided the final clue as to the problems with Well No. 5. Photographs 3.7, 3.8, and 3.9 show the strainer around the pump inlet on the pump removed from Well No. 5. Although some sand from the land surface has attached to the strainer where it was resting on the ground prior to the photographs being taken, the photographs show rounded fragments of sandstone from the aquifer matrix plugging the holes in the strainer. The rounded fragments of sandstone are much larger than the well screen slot size. Therefore, there is only one way they could have entered the well and that is through a damaged well screen.

Photograph 3.7: Strainer on Well No. 5 pump inlet partially plugged with sandstone fragments.

The presence of sandstone fragments in the pump strainer indicates that filter pack is not present around a significant area of the screen, perhaps not anywhere above the damaged portion of the well screen. This, and the evidence of a damaged well screen, indicates the well probably should be replaced by a properly constructed well for the simple reason it is pumping sand. As long as the well is pumping sand, it will damage pumps. It would be worthwhile to obtain a downhole video log of this well to determine the nature of the damage to the screen before making a final decision about a course of action, but the most likely outcome is that the well should be replaced.

In view of all the condition of Well No. 5, it is not desirable to pump the well as the sand production will continue to damage the pumps. In part this is because it was not possible to determine the pumping water level during operation of the well during its operation in December 2001. However, it is mostly because of the evidence that the well not only pumps air at 140 gpm, a condition damaging to the pump, but that the well also is pumping rather large fragments of sandstone derived from the aquifer matrix.

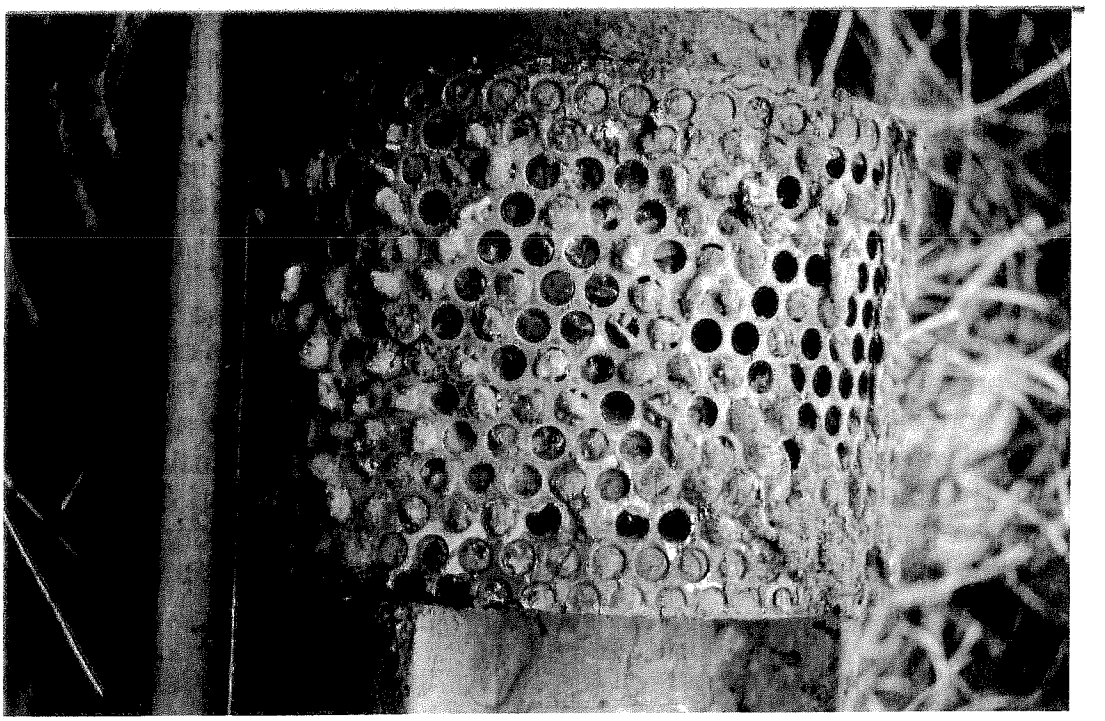
Photograph 3.8: Close-up view of sandstone fragments in pump inlet strainer.

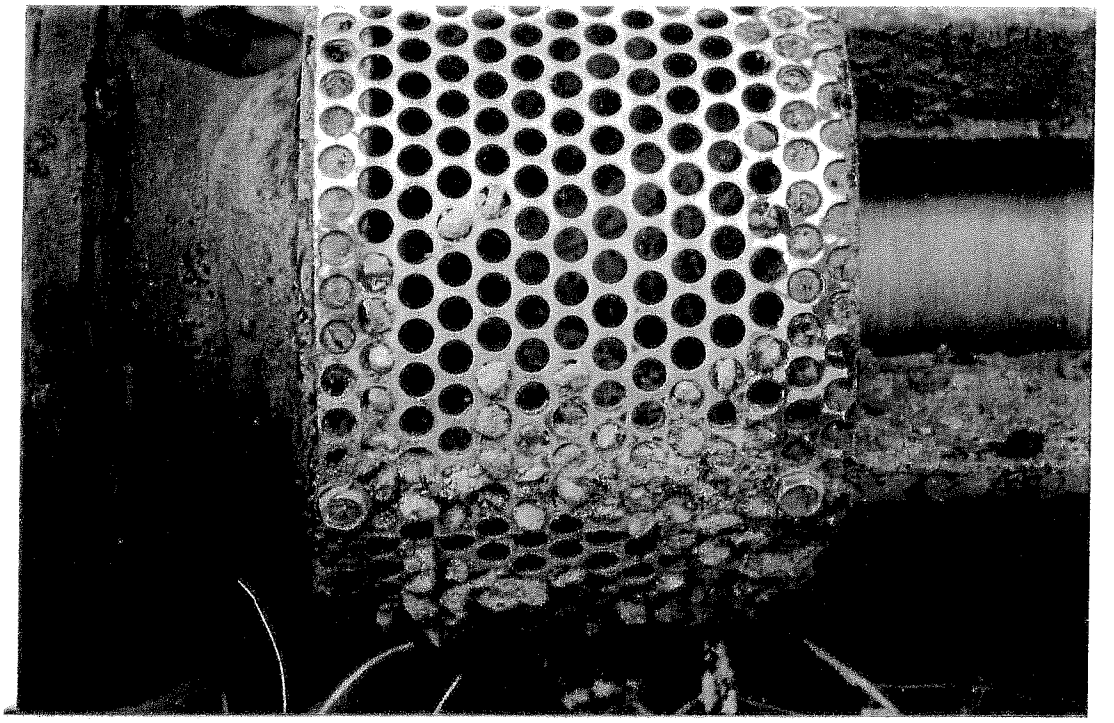
Photograph 3.9: Close-up of Well No. 5 pump inlet strainer.

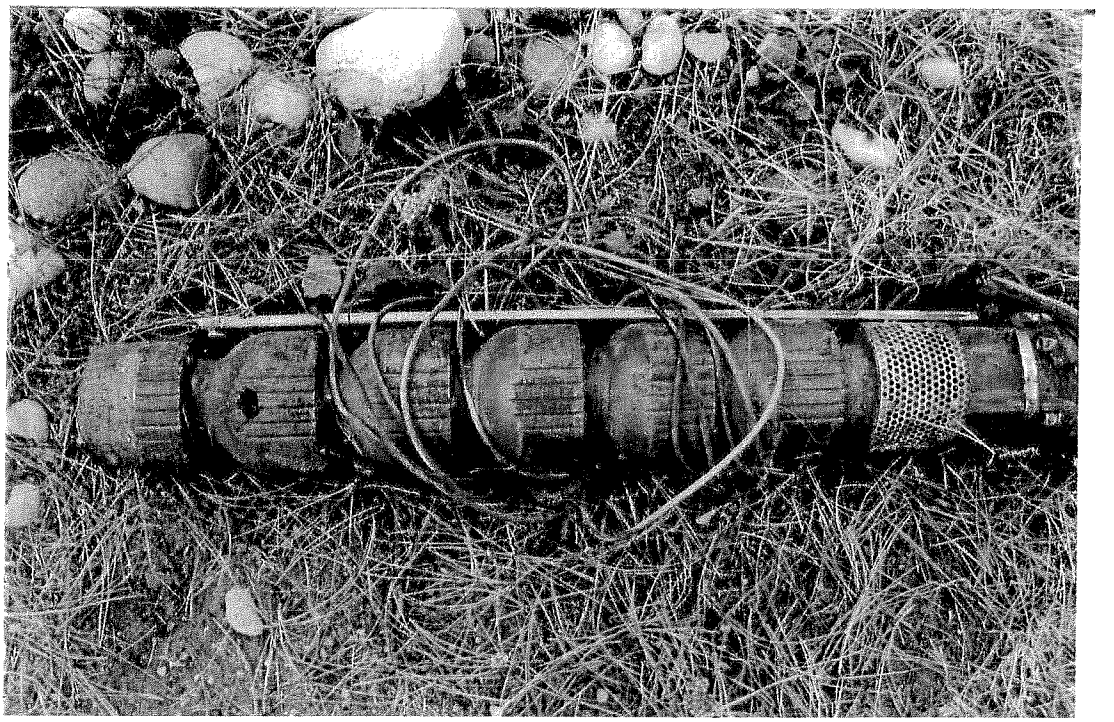
Photographs 3.10, 3.11 and 3.12 show that one side of the pump contains an impression of the well screen. The vertical grooves in the outside of the pump body are from the vertical rods in the well screen wearing into the cast iron housing of the pump. The small horizontal grooves between the large vertical grooves are an impression of the v-shaped wire which is continuously wrapped around the vertical rods to provide the slots into the screen. Accordingly, Photographs 3.10, 3.11 and 3.12 show that the motion of the pump, each time it torques during starts and stops, and as it vibrates slightly during operation, has worn an impression of the inside of the well screen into the pump body.

The impression of the well screen on the side of the pump from Well No. 5 shows that either the well is not straight or the well screen has partially collapsed. Although the

Photograph 3.10: Pump from Well No. 5, strainer at bottom end.

available information is not diagnostic, it is well known that operating a surge block inside a well screen, as documented in the field notes on Table 3.11, offers a risk that suction on the low-pressure side of the surge block may partially or fully collapse the well screen. Partial collapse of the screen into an oval shape is usually accompanied by separation of some of the v-shaped wire from the vertical rods, thus providing openings into the well screen that are much larger than the original slot size.

The impression of the well screen on one side of the production pump and the presence of relatively large fragments of sandstone in the pump strainer on Well No. 5 are conclusive evidence of damage to the well screen. It is not known if the screen was damaged due to partial collapse during application of the surge block for development or simply damaged by rough handling when it was installed. Another possibility is that it has been damaged by contact with the pump, although there is no evidence of this in the impression on the pump. The field notes indicating that SAPP (sodium acid pyrophosphate) was applied during development indicates that bentonite fluid was used during drilling of the borehole since SAPP is used to break down bentonite additives. This in turn indicates the drillers switched from air rotary drilling to mud rotary drilling, a change that is usually the result of unstable, caving formation that will not support an open borehole when drilling with air. Accordingly, this is evidence of serious borehole instability and caving when the well was drilled.

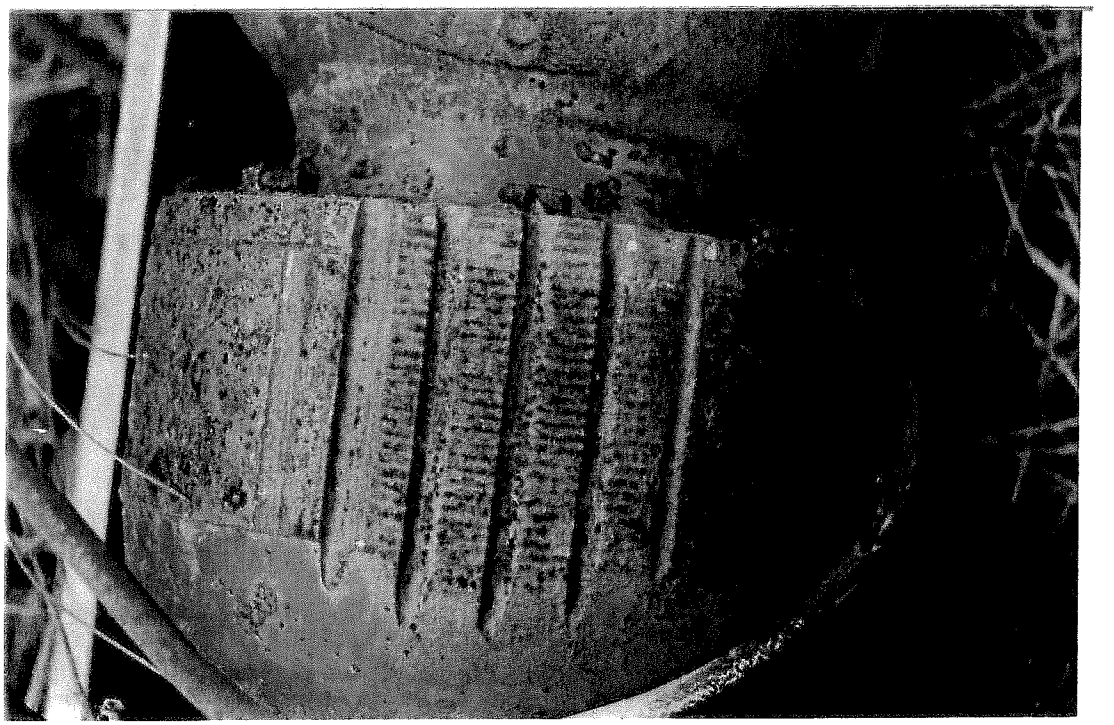
Photograph 3.11: Close up of screen imprint in pump body at Well No. 5.

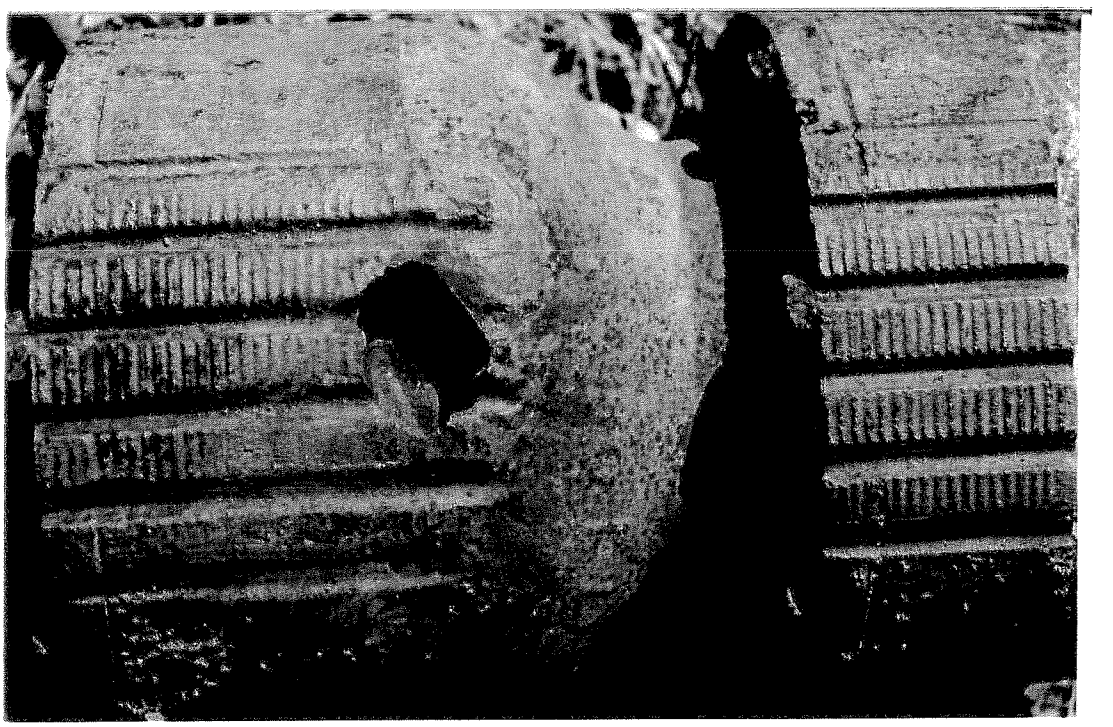
Photograph 3.12: Hole through top impeller housing of Well No. 5 pump.

Photographs 3.10 and 3.12 show the impression of a well screen worn into the pump removed from Well No. 5 as well as a hole through the housing around the impellers on the uppermost stage of the 5-stage pump. Although sand may have played a role in enlarging the hole by erosion, the hole is typical of the damage caused by air entrained in the water passing through the pump. The damage is caused by a process called cavitation.

A second way cavitation occurs is entrainment of air bubbles in the water entering the pump inlet. As the pressure in the column of water flowing through the pump is increased by the force of the impellers, the entrained bubbles collapse, causing cavitation and damage to the pump. In view of Frank William's observations of "white water" discharging from the pump, there is little doubt that the hole in the uppermost pump bowl at Well No. 5 (Figures 3.10 and 3.12) was caused by entrained air and cavitation. It should be noted that the location of the highest pressure in a vertical turbine submersible pump like that used in Well No. 5 is in the uppermost pump bowl and is therefore where cavitation is likely to be most severe with entrained air. When cavitation is due to excess velocity at the pump impeller (instead of entrained air), the cavitation damage usually occurs in the first or lowermost stage of the pump bowls. Therefore, the fact the hole is in the uppermost stage of the pump is an indication that the cause is probably entrained air, rather than cavitation caused by excess flow velocity at an impeller.

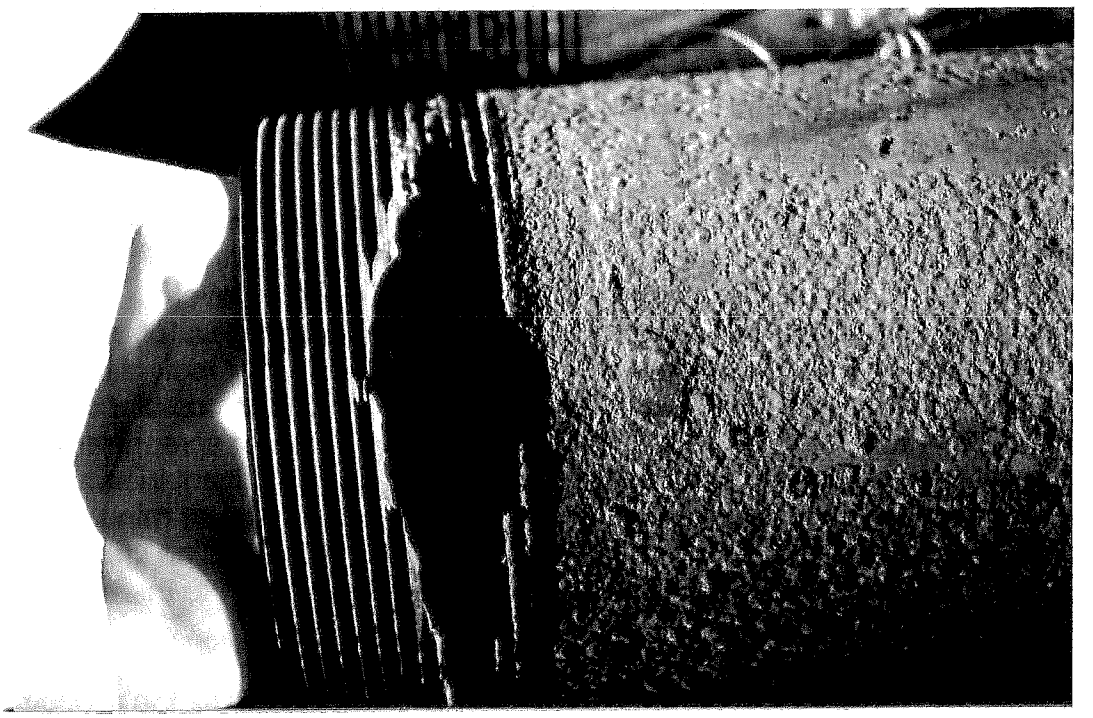
Photographs 3.13 and 3.14 show a hole that developed in the pump column pipe above the pump and check valve as the result of air entrained in the discharge water. The December 2001 pump production of 338-345 gpm from a pumping water level of about 150-151 feet, combined with the physical evidence of damage in the pump column by entrained air, indicates the pump impellers and seats were damaged over a period of time by entrained air. The damage ultimately reduced the capacity of the pump to the present production rate. It is probably not a coincidence that the present yield and drawdown performance maintains a pumping water level slightly below the top of the well screens as shown on Figure 3.38, exactly the maximum pumping level below which cascading water and air entrainment will begin to occur in the well. Progressive damage to the pump and associated loss of capacity eventually brought the yield and drawdown performance into equilibrium with a pumping water level at which cascading water and entrained air ceased.

Photograph 3.13: Hole in pump column at Well No. 9 due to entrained air.

Photograph 3.14: View through hole in pump column at Well No. 9.

Under these circumstances, the best approach may be to leave the existing pump in the well and let it continue to adjust to the declining water level until it fails. If it is necessary to replace the pump in the next two years, a pump capable of providing 250 gpm with a total dynamic head of 274 feet might be a good choice, depending on the shape of the pump performance curve. A pump with the appropriate performance curve will automatically pump less water as lift on the pump increases due to a declining groundwater level in the future. This will ultimately result in the pump operating in an inefficient head-discharge range, but will allow the pump yield to decrease in response to declining groundwater level. For example, a Grundfos 300S00-5 (30 hp) will produce about 300 gpm at 274 feet total dynamic head (TDH) and 78 percent efficiency; 240 gpm at 314 feet TDH and 76 percent efficiency; and 195 gpm at 354 feet TDH and 71 percent efficiency. The latter pump is offered as an example of a pump selection principle, not as a recommendation for that specific pump for Well No. 9.
